Back-analysis of the rockburst in Frieda 5 and design program for panel in seam 6 (HBL-France)

Vincent Renaud, Lynda Driad, Marwan Al Heib, J.-F. Noirel

BACK-ANALYSIS OF THE ROCKBURST IN FRIEDA 5 AND DESIGN PROGRAM FOR PANEL IN SEAM 6 (HBL – FRANCE)

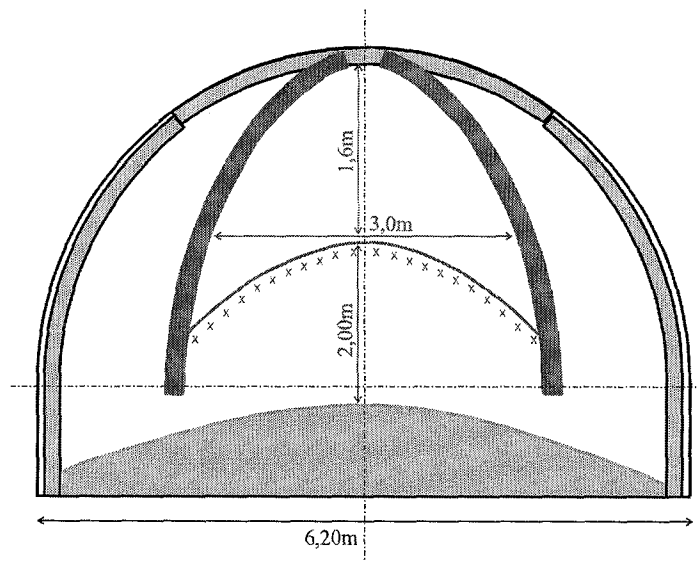
On June 21 2001, a fatal rock burst affected the main gate of the Frieda 5-1250 panel in the Merlebach Mine (HBL). The rock burst was extremely violent (magnitude 3.6). The heave exceeded 2 m (figures 1 and 2, HBL note number 384/01-JPA/ND [3]). The damaged zone was 250 m long and was located at between 100 m and 350 m in front of the face (between the sides).

Fig. 1: Diagram showing bottom level blow off.

The seismic focus of the 21/06/01 event is located on the Frieda5 main gate 100 m in front of the face (figure 1). The location in depth shows that the depth of the focus of this event is about 1400 m (estimated depth below the surface, figure 2) at 200 m from the Frieda5 cutting face.

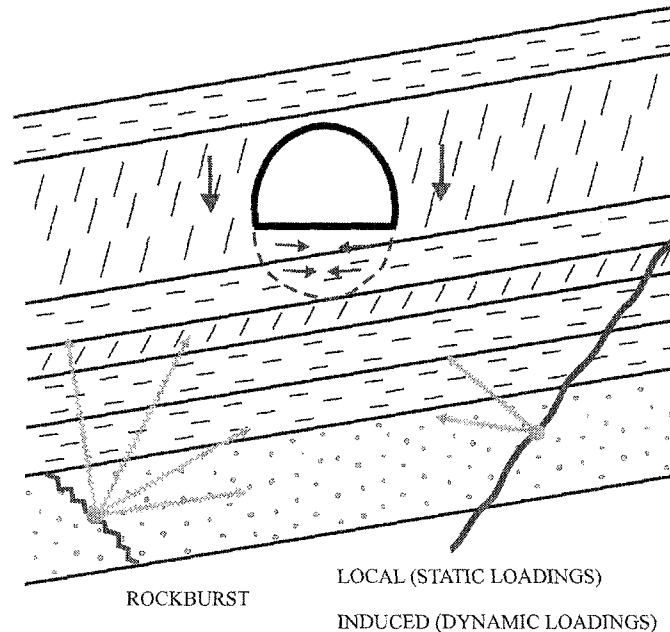
In the case of the June 21 2001 event, the analysis of the direction of the first movement demonstrated an explosive rupture mechanism. More explicitly, the movement of the wave was a pure compression. Events recorded before the accident, and particularly the 21/06/2001 event at 19h 38 (~ 20 min before the accident), show a shear mechanism (figure 2).

Fig. 3: The identified rupture mechanism

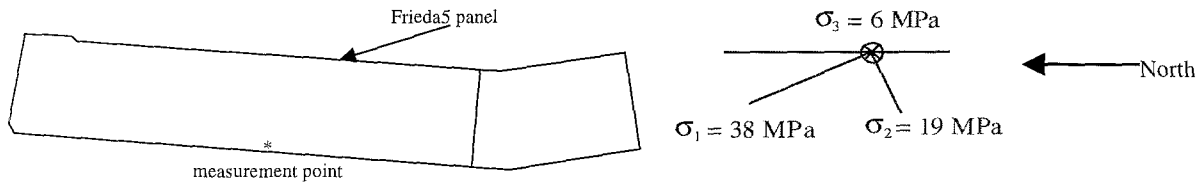
Stress measurements show that horizontal stresses are very high and the vertical stress is less than the weight of the ground (figure 4).

Fig. 4: Stress diagram in accident zone

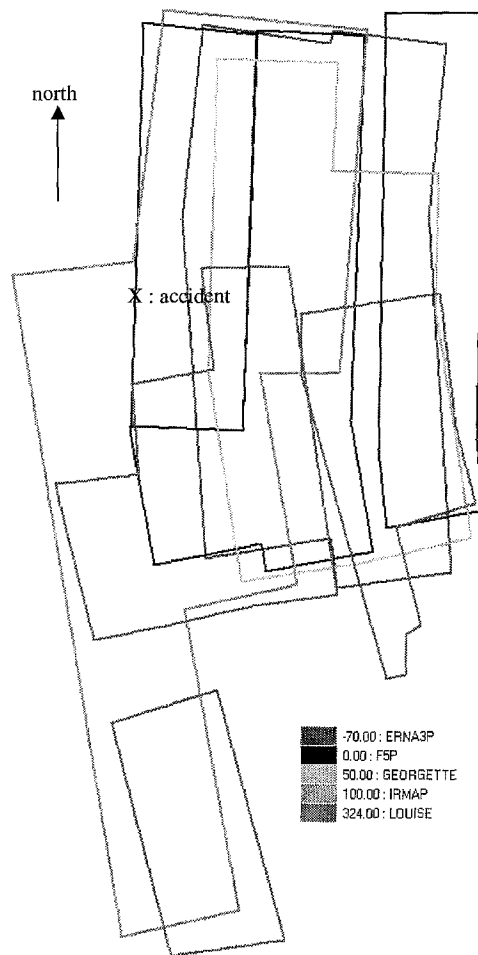
The model using the SUIT3D program ([8], figure 5) was intended to achieve two objectives, firstly to find the initial tensor before mining started, and variations in the stress tensor close to the area of the accident [2]. The calculation was made assuming linear elasticity, with an isotropic stress tensor over the scale of the deposit. The seams considered in the calculation are shown in table 1.

Fig. 5: Modeled seams with SUIT3D

- mining operations in the Irma-1250 panel considerably modified the distribution of normal, horizontal and axial stresses. The influence of Erna3 and Frieda5 operations is lower and never exceeds 20%;
- overstress areas correspond to the Louise TB zone and the zone ahead of the Irma-1250 face;
- in the intermediate zone (where the part of the Frieda5-1250 panel on which mining operations are taking place is located, and the part of the bottom level affected during the accident); the vertical stress in these zones is relieved;
- furthermore, the influence of mining operations in the Frieda5-1250 panel is limited to zones close to the part of the panel from which coal has been extracted, and in particular it appears weak in the part of the level affected by the accident.

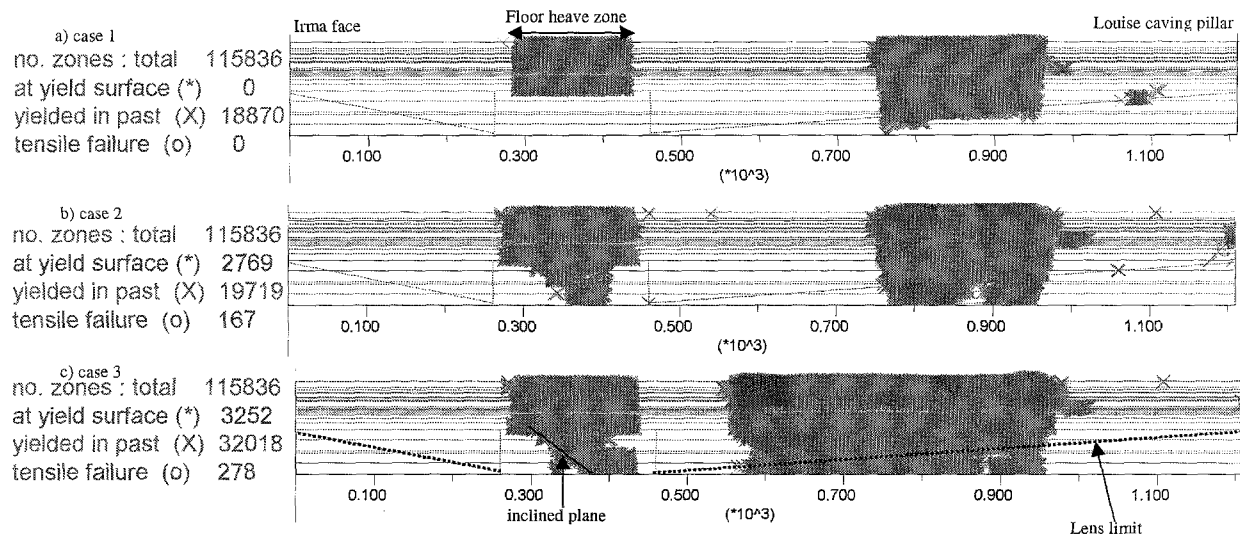
The mechanism studied would appear to be capable of reproducing total deconsolidation of the bed under some conditions (figure 6):

- the vertical stress relief in the accident zone must be less than or equal to 4 MPa;
- the North-South horizontal stresses must be high (higher than 60 MPa and therefore higher than the measurements made in situ);
- East-West horizontal stresses, and particularly shear stresses, are design parameters that are less sensitive than the previous two;
- the compression strength (R_c) of the sandstone bed had to be halved so that the second sandstone bench could be fractured.

Fig. 6: Overview: distribution of plasticity

Case 1: 200 m advance

Case 2: 200 m advance, effect of the axial horizontal stress

Case 3: 400 m advance, effect of stress gradients

- 1) a bottom case with a variable thickness sandstone bed (between 0 m and 20 m) and a 125 m wide zone in which vertical stresses were relieved;
- 2) a bottom case mode with N-S horizontal stresses increased by 25 %;
- 3) same mode as above (case 2) but with the Frieda 5 face advanced by 400 m, which is close to the accident configuration.

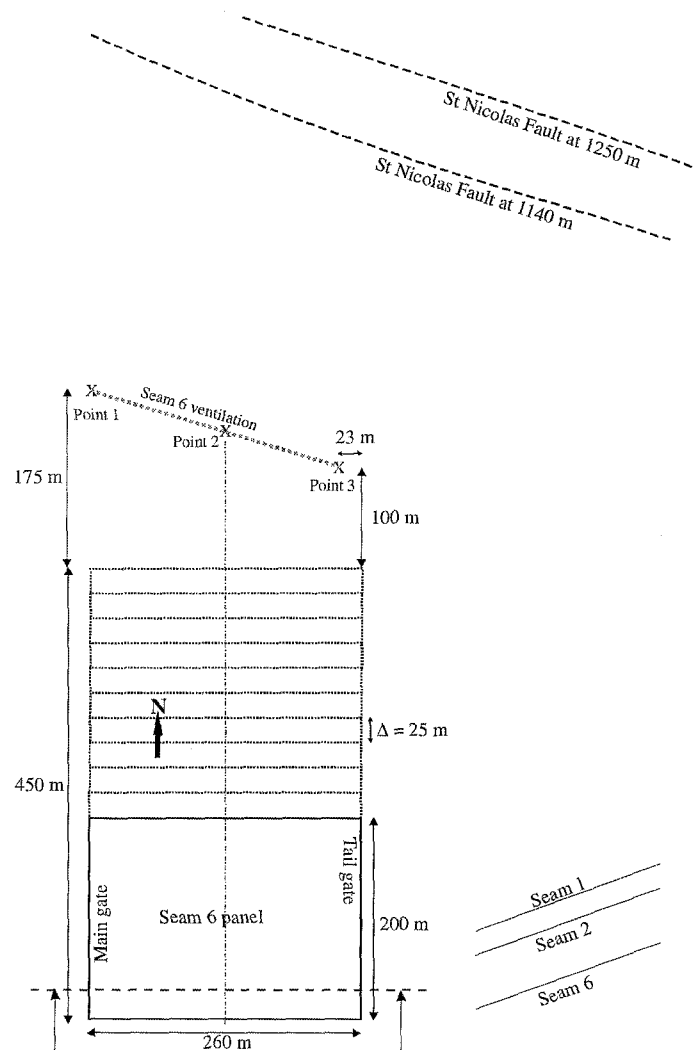
The advance of the panel between 200 m and 470 m (maximum length) is simulated in 12 steps (figure 5). The model includes all mined panels of the Reumaux Mines (HBL).

Fig. 5: Different steps in modeling the advance on the Seam 6 panel.

The results were analyzed considering the variation of the state of stress with the advance of panel 1140-1250 (figure 5). The comments can be made on this model:

- operation of the Seam 6 panel will have an influence ahead of the faces of the Seam 1 and 2 panels starting from an advance of 325 m. This is a very small modification compared with the initial state before operation of the panel;

- starting from 400 m, the influence becomes more significant. It corresponds to an increase in the normal stress (zones close to the roof track increase by 2 MPa, the 28 MPa contours move by 110 m ahead of the face on the bottom level) and an increase in the east-west horizontal stress at the face of the 1st panel in Seam 1 (increase of 2 MPa);

- in the ventilation zone, the greatest increase concerns the east-west horizontal stress, which is 15% of the initial value. The normal stress only increases by 5%. No modification is observed for the north-south horizontal stress;

- the front ends of Seams 1, 2 and 6 do not intersect until the advance reaches 450 m (the planned length).
